SERVICE No. 1174 BULLETIN

Date: February 15, 2007

**LOCK ASSEMBLY- CABIN ENTRANCE DOOR,
FORWARD BAGGAGE DOOR, AFT BAGGAGE
DOOR, and NACELLE LOCKER DOOR**

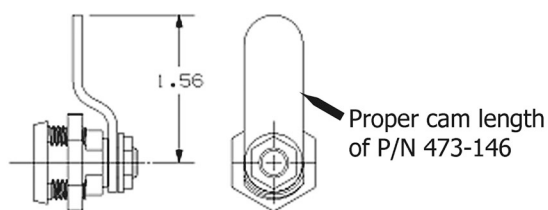
**Figure 1
(Correct Length)**

It has been discovered that between March 2006 and May 2006 the Piper factory shipped lock assembly P/N 473-146, which may not meet the drawing specifications for cam length. Piper drawing 25163-003 requires the cam to measure 1.56 inches from the center of the lock to the tip of the cam (See Figure 1).

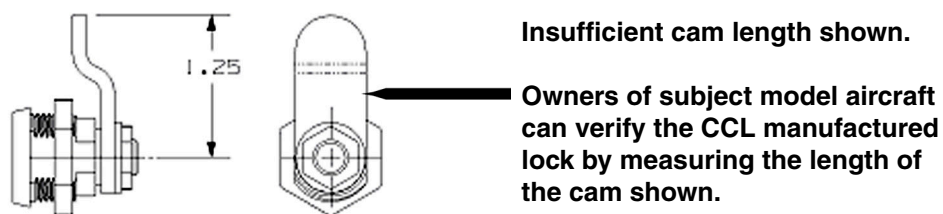
**Figure 2
(Incorrect Length)**

The lock assemblies shipped between March 2006 and May 2006 (manufactured by CCL Security Products under the Piper code number 473-146) have a reduced cam length. The measurements of these cams are 1.25 inches from the center of the lock to the tip of the cam (See Figure 2).

Left uncorrected, the shortened cam could result in locking mechanism failure or a latching failure, allowing the door to be opened.

1. At all applicable locations where Piper Lock Assembly P/N 473-146 is required, perform the inspection described in this Service Bulletin. If the cam length from axis of rotation to end of cam is 1.56 inches at all locations, proceed to Step 3. If any cam does not measure at least 1.56 inches, proceed to Step 2.

2. For each 473-146 lock assembly that does not meet the 1.56 inch dimensional requirement, order and install Lock Modification Cam Lock Replacement Kit, Piper Part Number 88406-002
3. Make a log book entry indicating compliance with Step1 and/or Step 2, as applicable.
